● Dry hobbing / countermeasure for scratch

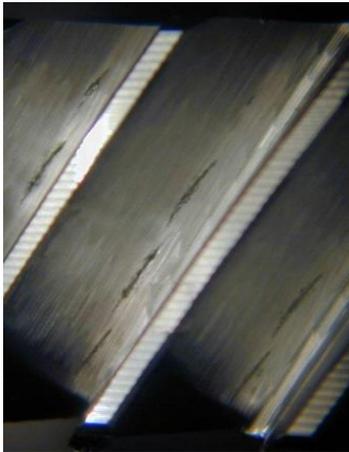
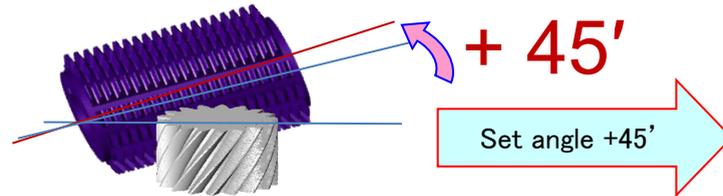
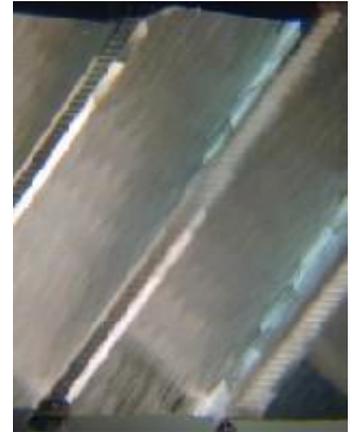
CASE 1 / Caused by chips immediately after generation

Scratches occur at the same position on all tooth surfaces.

SCRATCH LEFT FLANK

Change the hob set angle in the range of about 15'to 1° (Fig 1 below) in the direction in which the approach angle of the hob cutting edge on the damaged tooth flank side larger (see Fig. 2 below).

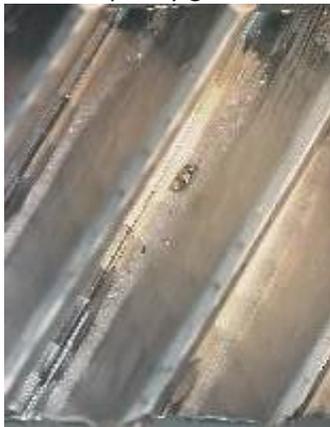
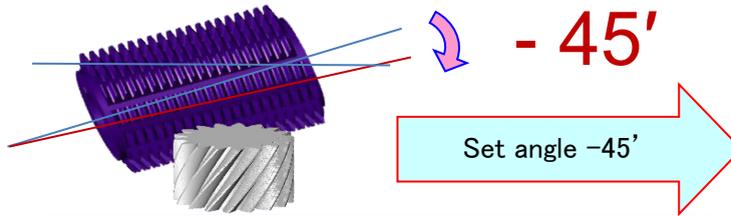
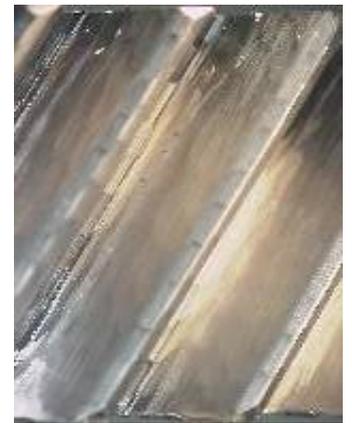
CASE 2 / Caused by the chips that have already been cut off and came into the cutting point again.

There are scratched and non-scratched teeth.
The chip may get welded on the tooth flank.

SCRATCH LEFT FLANK

Change the mounting angle in the range of about 15'to 1° (Fig 1. below) in the direction in which the approach angle of the hob cutting edge on the damaged tooth flank side becomes smaller.
Also, keep the direction of the air nozzle as close to the cutting point as possible to keep chips away from

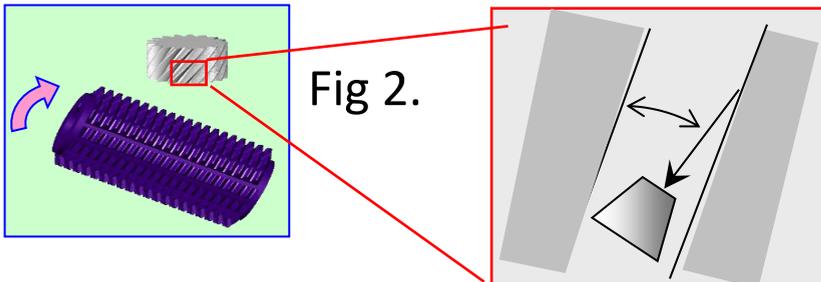
Fig 1. By set angle adjustment, Part tooth thickness decreases.

Angle	Amount
15'	-2μm
30'	-8μm
45'	-18μm
1°	-32μm

(m2, α20°, HOB ODφ80)
